**Flood Control Project Maintenance
Levee Inspections**
LMA District Cover Sheet
Spring 2017 Levee Inspection Results

Reclamation District No. 2063 Crows Landing

Spring 2017 Levee Inspection Results

Waterway			Bank	Unit Miles
Unit No. 01 San Joaquin River			Right	10.44
	Spring (March - May)	Summer (June - August)	(September - November) Fall	Winter (December - February)
Unit Maintenance Rating (Fall Only)				
Date of Inspection	4/11/2017 - 4/11/2017			
DWR Inspector	Richard Willoughby			
Accompanied By

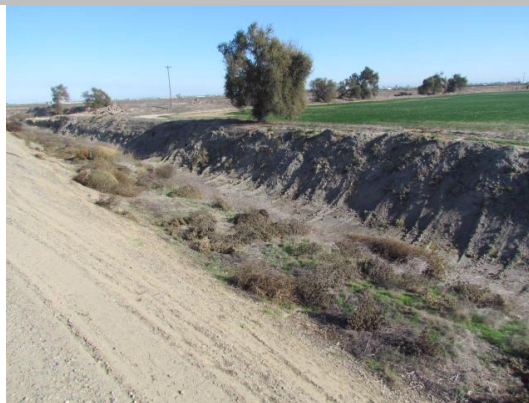
Photo 2 of 3 : SP_2017_RD2063_112_18_20170411_00007.jpg

LM Start	0.02	Rating **	U	Issue No.	18 (cont)	
LM End	1.30	Issue Type +	En	Location *	LS	
Category	Earthen Levee			GPS Latitude/Longitude		
				Start		End
Item	Encroachments			37.478470 °		37.464660 °
				-121.044598 °		-121.032946 °
DWR ID	DWR_RD2063_01_s_2012_18					
Comment Code						
DT : Ditch						
Inspector Comment						
Ditch on landside has encroached into the berm and toe of the levee.

Looking northeast at canal-ditch on landside berm.

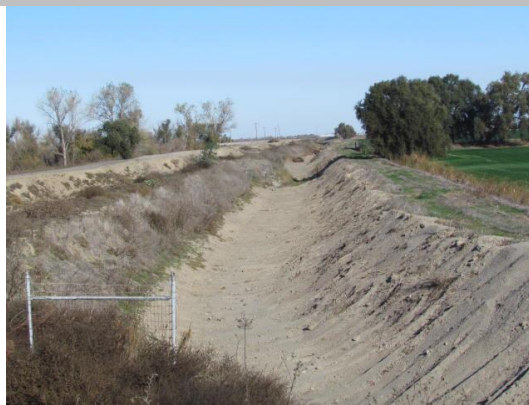
Photo 3 of 3 : SP_2017_RD2063_112_18_20170411_00008.jpg

Looking south at canal-ditch at landside berm and toe.

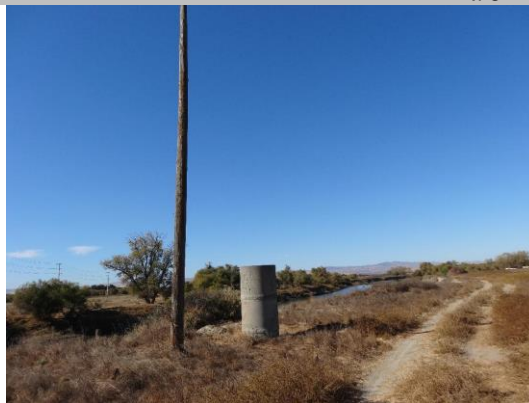
Photo 1 of 3 : UCIP_SP_2017_50216_43166.jpg

11/05/2013:- Pipe has visible holes throughout both LS and WS along with pipe deformation. - looks abandoned. Needs proper abandonment.- alfalfa valve on concrete pipe riser on waterside toe.- no slide gate found on waterside. No pump and pile structure found in river.

FIELD_STRUCT_DESC: *ABANDONED* 24-inch corrugated metal (CMP) pipe through the levee, 10 feet below the crown, not found during 2016 inspection. Pipe was supported on two timber pile bents across a drain ditch on the landside (LS) (only pile remnants found during 2016 inspection). Two concrete standpipes on waterside (WS) berm, one of which was found during the 2016 inspection. [Additional Reference(s): DWR Levee Log, 1992. USACE San Joaquin O&M Manual 006, Sep 1961 (HLM 1.29)].

WS view: abandoned concrete standpipe and abandoned power pole.

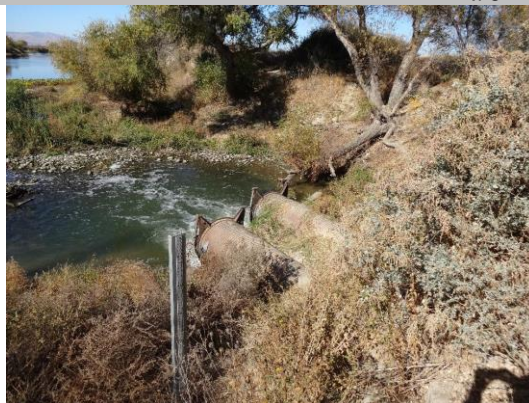
Photo 1 of 3 : UCIP_SP_2017_50218_43204.jpg

Comment Code					
Inspector Comment					
FS_ID:50218					
DS_ID:22076					
EP_NO: N/A					
Repair Type: No Action Needed					
Crossing Status: Found					
UCIP Comments: 08/23/2016: WS flapgates were held open by a piece of wood. Pipes may be used temporarily for irrigation. (K. Fazel - UCIP)11/05/2013: working during the inspection. (P. Amatya - DWR)					
FIELD_STRUCT_DESC: 1 of 2: Gravity drain structure. Two 48-inch CM pipes through the levee 25.5 feet below the crown. Slide gates in CM pipe risers on the waterward slope. Flap gates on the waterward ends. Cobble spillway 70 feet in length to river. (Lateral Drain No. 5) installed by USCE 1961. O&M Manual SJR 006, Sept. 1961.					
FS Date: 11/5/2013

WS view: two outfall CMP pipes on levee slope.

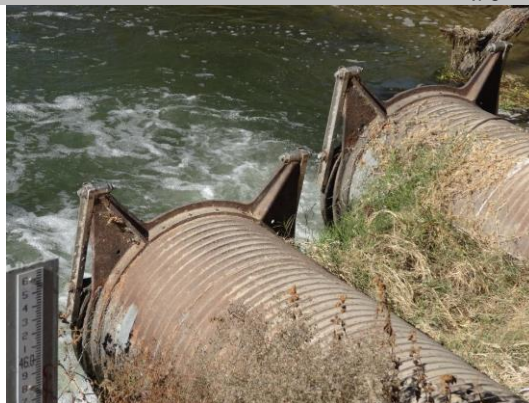
Photo 2 of 3 : UCIP_SP_2017_50217_43216.jpg

Comment Code					
Inspector Comment					
FS_ID:50217					
DS_ID:22119					
EP_NO: N/A					
Repair Type: No Action Needed					
Crossing Status: Found					
UCIP Comments: 08/23/2016: WS flapgates were held open by a piece of wood. Pipes may be used temporarily for irrigation. (K. Fazel - UCIP)11/05/2013: working during field inspection. (P. Amatya - DWR)					
FIELD_STRUCT_DESC: 2 of 2: Gravity drain structure. Two 48-inch CM pipes through the levee 25.5 feet below the crown. Slide gates in CM pipe risers on the waterward slope. Flap gates on the waterward ends. Cobble spillway 70 feet in length to river. (Lateral Drain No. 5) installed by USCE 1961. O&M Manual SJR 006, Sept. 1961.					
FS Date: 11/5/2013

WS view: two CMP outfall pipes with flap gates on levee slope.

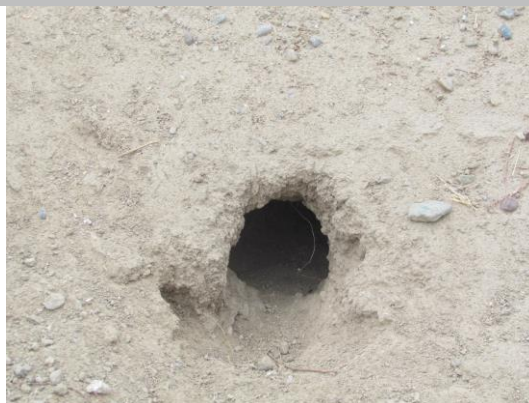
Photo 2 of 2 : SP_2017_RD2063_112_11_20170411_00005.jpg

LM Start	1.71	Rating **	A/W	Issue No.	11
LM End	1.74	Issue Type +	Ma	Location *	LS
Category	Earthen Levee			GPS Latitude/Longitude	
				Start	End
Item	Animal Control			37.459209 °	37.458964 °
				-121.033126 °	-121.033420 °
DWR ID	DWR_RD2063_01_s_2012_11				
Comment Code					
A3 : No rodents visible, but rodent burrows visible; need to backfill and compact or grout burrows.					
Inspector Comment					
Several rodent holes noted on landward slope.

Looking at close-up view of rodent hole on landward slope.

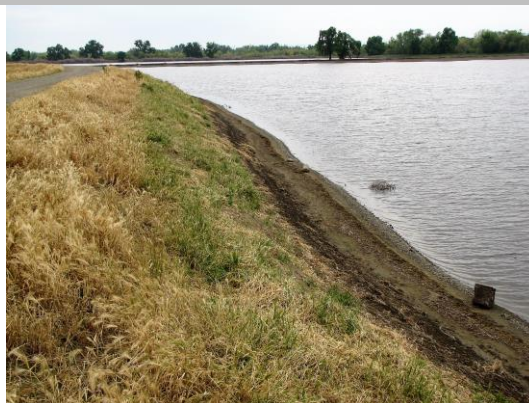
Photo 2 of 2 : SP_2017_RD2063_112_59_20170411_00122.jpg

LM Start	1.83	Rating **	M	Issue No.	59 (cont)	
LM End	1.93	Issue Type +	Ma	Location *	WS	
Category	Earthen Levee			GPS Latitude/Longitude		
				Start		End
Item	Erosion / Bank Caving			37.457653 °		37.456258 °
				-121.033728 °		-121.033645 °
DWR ID	DWR_RD2063_01_s_2017_59					
Comment Code						
E1 : Note and monitor erosion site.						
Inspector Comment						
Minor erosion at waterward toe.

Looking upstream at minor erosion on waterward slope.

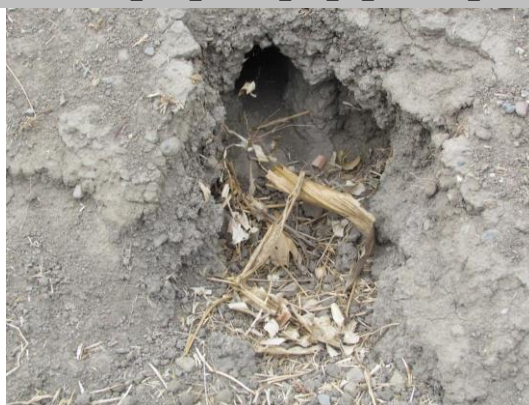
Photo 1 of 2 : SP_2017_RD2063_112_46_20170411_00013.jpg

LM Start	2.01	Rating **	A/W	Issue No.	46
LM End	2.01	Issue Type +	Ma	Location *	LS
Category	Earthen Levee			GPS Latitude/Longitude	
				Start	End
Item	Animal Control			37.455136 °	37.455136 °
				-121.032912 °	-121.032912 °
DWR ID	DWR_RD2063_01_f_2016_46				
Comment Code					
A3 : No rodents visible, but rodent burrows visible; need to backfill and compact or grout burrows.					
Inspector Comment					
Three large rodent holes on landward slope.

Looking at close-up view of rodent hole with corn husk at the entrance of the hole.

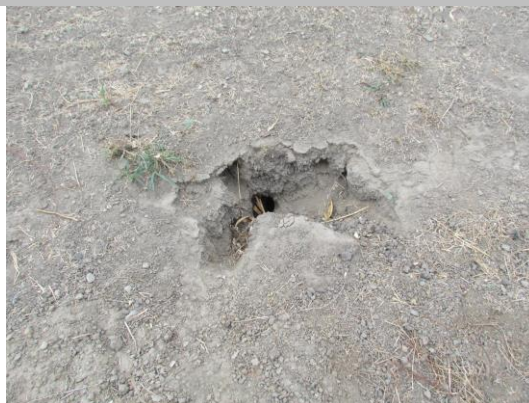
Photo 2 of 2 : SP_2017_RD2063_112_46_20170411_00014.jpg

Looking at large rodent hole on landward slope.

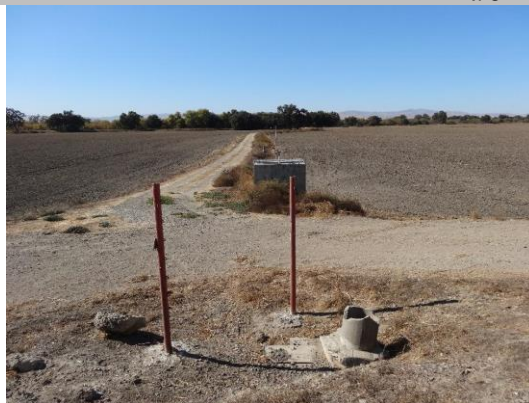
Photo 1 of 3 : UCIP_SP_2017_24404_43345.jpg

LM Start	2.09	Rating **	M	Issue No.	64
LM End	2.09	Issue Type +	En	Location *	LS
Category	Supplemental			GPS Latitude/Longitude	
				Start	End
Item	DWR UCIP Field Study			37.454125 °	37.454125 °
				-121.032240 °	-121.032240 °
DWR ID					
Comment Code					
Inspector Comment					
FS_ID:24404					
DS_ID:22078					
EP_NO: N/A					
Repair Type: Non-Urgent					
Crossing Status: Found					
UCIP Comments: Concrete distribution box with alfalfa valve not found at the waterward toe.Two steel standpipes and dismantled concrete standpipe on waterside levee toe.Concrete distribution box 50 ft off the levee center.					
FIELD_STRUCT_DESC: 30-inch CM pipe through the levee 16.5 feet below the crown. Slide gate in concrete distribution box 50 ft off the levee. Underground irrigation system. Installed by USCE 1961. O&M Manual SJR 006, Sept. 1961.					
FS Date: 11/5/2013

WS view: concrete box (top), and a dismantled concrete pipe on levee toe.

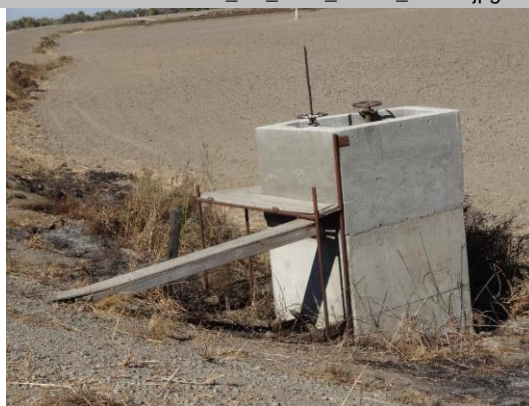
Photo 2 of 3 : UCIP_SP_2017_51823_43347.jpg

LM Start	2.27	Rating **	A/W	Issue No.	65 (cont)	
LM End	2.27	Issue Type +	Ma	Location *	LS	
Category	Supplemental			GPS Latitude/Longitude		
				Start		End
Item	DWR UCIP LMA Responsibility			37.451946 °		37.451946 °
				-121.030672 °		-121.030672 °
DWR ID						
Comment Code						
Inspector Comment						
FS_ID:51823						
DS_ID:22081						
EP_NO: N/A						
Repair Type: No Action Needed						
Crossing Status: Found						
UCIP Comments: - concrete standpipe on waterside toe.- concrete distribution box on landside.- an alfalfa valve on waterside toe.						
FIELD_STRUCT_DESC: 30-inch CM pipe through the levee 12.0 feet below the crown. Flap gate on waterward end. Slide gate in distribution box on landward end. Concrete "U" headwall on the waterward end.						
O&M Manual SJR 006, Sept. 1961.						
FS Date: 11/5/2013

LS view: concrete distribution box and temporary walkway on levee toe.

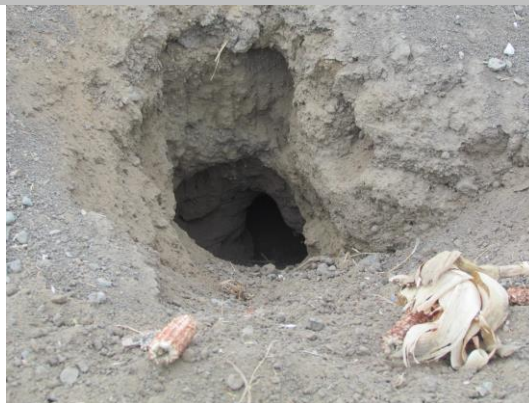
Photo 1 of 3 : SP_2017_RD2063_112_47_20170411_00015.jpg

LM Start	2.34	Rating **	A/W	Issue No.	47
LM End	2.37	Issue Type +	Ma	Location *	LS
Category	Earthen Levee			GPS Latitude/Longitude	
				Start	End
Item	Animal Control			37.451394 °	37.451064 °
				-121.029426 °	-121.029072 °
DWR ID	DWR_RD2063_01_f_2016_47				
Comment Code					
A3 : No rodents visible, but rodent burrows visible; need to backfill and compact or grout burrows.					
Inspector Comment					
Large rodent holes on landward slope.

Looking at close-up view of rodent hole with corn and corn husk at the entrance of hole.

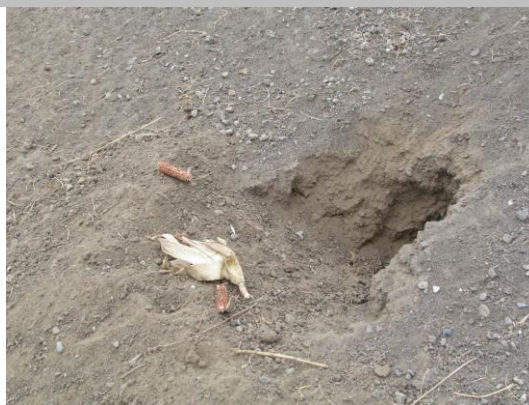
Photo 2 of 3 : SP_2017_RD2063_112_47_20170411_00016.jpg

Looking northwest at rodent hole on landward slope.

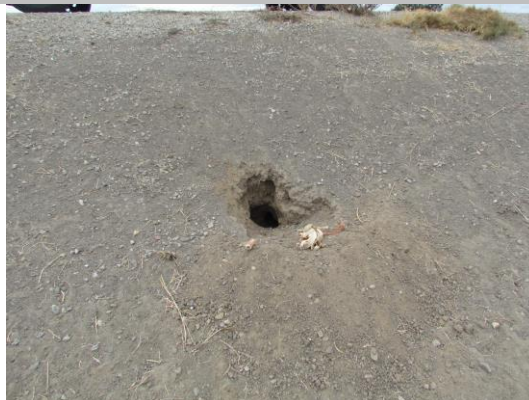
Photo 3 of 3 : SP_2017_RD2063_112_47_20170411_00017.jpg

Looking west at rodent hole on landward slope.

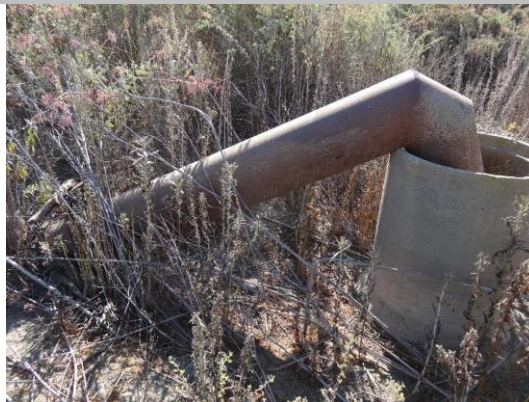
Photo 3 of 3 : UCIP_SP_2017_24427_43437.jpg

Comment Code					
Inspector Comment					
FS_ID:24427					
DS_ID:22085					
EP_NO: N/A					
Repair Type: Non-Urgent					
Crossing Status: Found					
UCIP Comments: Abandoned steel pipe and service pole on waterside.					
Pump not found on river bank. CMP riser on waterside slope. Slide					
gate not found in CMP riser. Steel pipe riser on waterside					
berm.Damaged PVC standpipe on waterside slope.					
FIELD_STRUCT_DESC: Abandoned 24-inch CM pipe through the					
levee 10.0 feet below the crown. 20-inch standpipe 3.0 feet from the					
landward toe. 12-inch pipe across the berm and into CMP riser on the					
waterward slope. Installed by USCE 1961. O&M Manual SJR 006, Sept.					
1961.					
FS Date: 11/5/2013

WS view: steel pipe and concrete riser on levee berm.

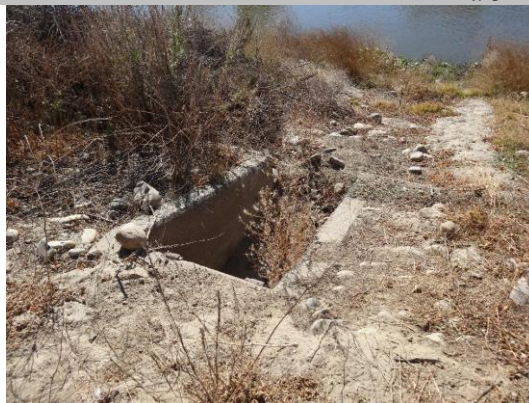
Photo 1 of 3 : UCIP_SP_2017_24435_43484.jpg

WS view: U shaped headwall outlet structure 70 ft off the levee center.

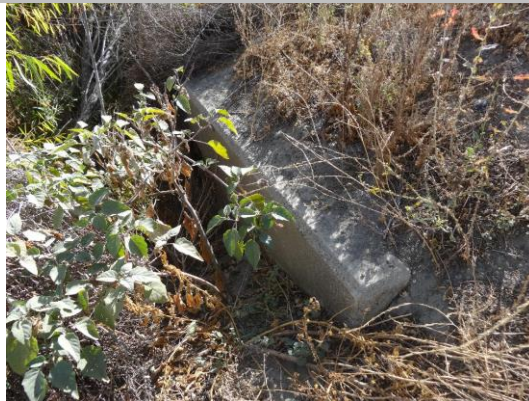
Photo 3 of 3 : UCIP_SP_2017_25023_45100.jpg

LS view: pipe and concrete headwall off the levee toe.

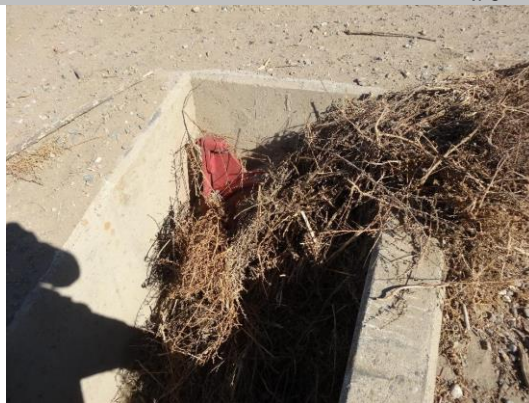
Photo 2 of 3 : UCIP_SP_2017_24443_43521.jpg

WS view: pipe, flap gate, and concrete headwall with debris blocking the outlet.

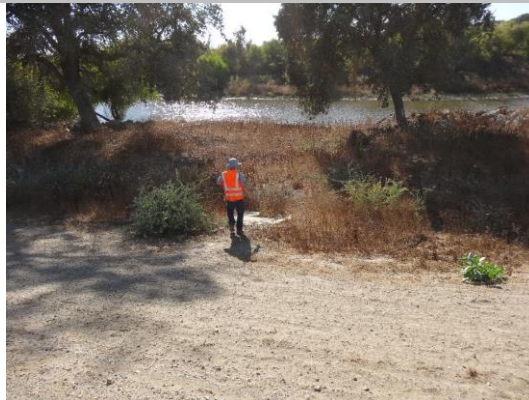
Photo 1 of 3 : UCIP_SP_2017_24469_43645.jpg

LM Start	3.29	Rating **	M	Issue No.	71
LM End	3.29	Issue Type +	Ma	Location *	LS
Category	Supplemental			GPS Latitude/Longitude	
				Start	End
Item	DWR UCIP LMA Responsibility			37.441213 °	37.441213 °
				-121.021130 °	-121.021130 °
DWR ID					
Comment Code					
Inspector Comment					
FS_ID:24469					
DS_ID:22089					
EP_NO: N/A					
Repair Type: Non-Urgent					
Crossing Status: Found					
UCIP Comments: - cleaning required in inlet pipe.- new flap gate					
FIELD_STRUCT_DESC: 24-inch CM pipe through the levee 12.5 feet					
below the crown. Flap gate on the waterward end. Concrete headwall					
on both ends. O&M Manual SJR 006, Sept. 1961.					
FS Date: 11/5/2013

WS view: U typed concrete headwall on levee toe

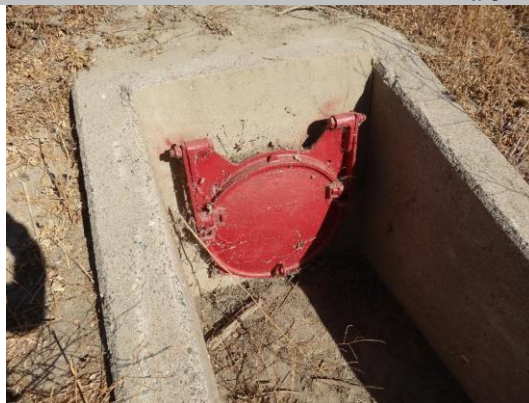
Photo 2 of 3 : UCIP_SP_2017_24469_43644.jpg

LM Start	3.29	Rating **	M	Issue No.	71 (cont)
LM End	3.29	Issue Type +	Ma	Location *	LS
Category	Supplemental			GPS Latitude/Longitude	
				Start	End
Item	DWR UCIP LMA Responsibility			37.441213 °	37.441213 °
				-121.021130 °	-121.021130 °
DWR ID					
Comment Code					
Inspector Comment					
FS_ID:24469					
DS_ID:22089					
EP_NO: N/A					
Repair Type: Non-Urgent					
Crossing Status: Found					
UCIP Comments: - cleaning required in inlet pipe.- new flap gate					
FIELD_STRUCT_DESC: 24-inch CM pipe through the levee 12.5 feet					
below the crown. Flap gate on the waterward end. Concrete headwall					
on both ends. O&M Manual SJR 006, Sept. 1961.					
FS Date: 11/5/2013

WS view: new flap gate, and U typed concrete headwall.

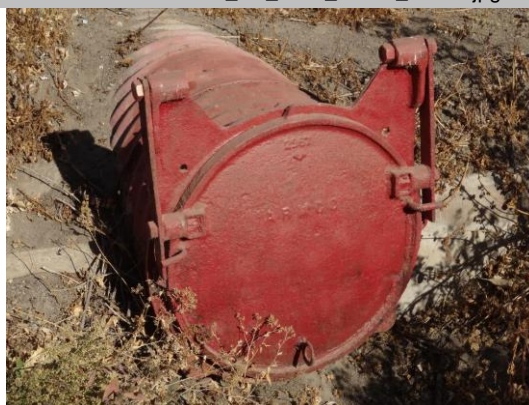
Photo 1 of 3 : UCIP_SP_2017_24485_43667.jpg

LM Start	3.64	Rating **	M	Issue No.	72
LM End	3.64	Issue Type +	Ma	Location *	LS
Category	Supplemental			GPS Latitude/Longitude	
				Start	End
Item	DWR UCIP LMA Responsibility			37.436845 °	37.436845 °
				-121.017826 °	-121.017826 °
DWR ID					
Comment Code					
Inspector Comment					
FS_ID:24485 DS_ID:22093 EP_NO: N/A Repair Type: Non-Urgent Crossing Status: Found UCIP Comments: - new flap gate on waterside.- cleaning and clearing of inlet box needed. FIELD_STRUCT_DESC: 24-inch CM pipe through the levee 12.0 feet below the crown. Flap gate and concrete saddle on the waterward end. Concrete drop inlet box on landward side. Installed by USCE 1961. O&M Manual SJR 006, Sept. 1961. FS Date: 11/5/2013

WS view: pipe, flap gate, and concrete saddle on levee slope

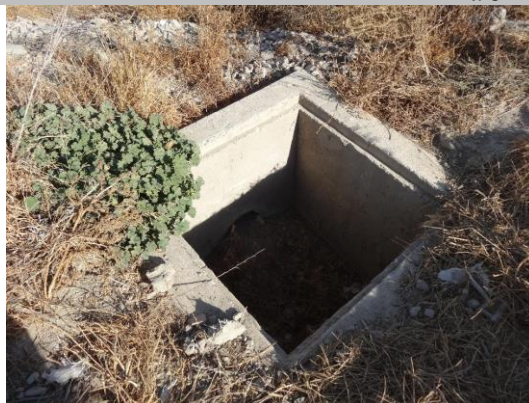
Photo 2 of 3 : UCIP_SP_2017_24485_43666.jpg

LS view: concrete drop inlet box on levee toe.

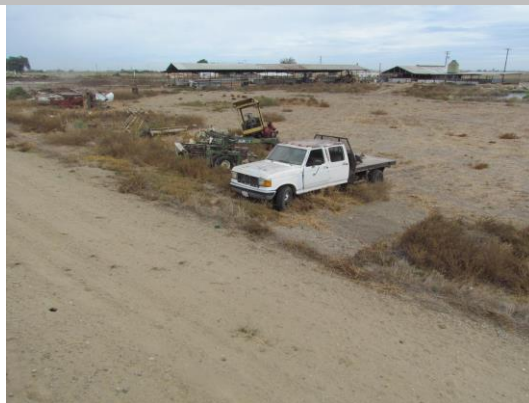
Photo 1 of 1 : SP_2017_RD2063_112_49_20170411_00018.jpg

LM Start	3.68	Rating **	M	Issue No.	49
LM End	3.68	Issue Type +	En	Location *	LS
Category	Earthen Levee			GPS Latitude/Longitude	
				Start	End
Item	Encroachments			37.436441 °	37.436441 °
				-121.017376 °	-121.017376 °
DWR ID	DWR_RD2063_01_f_2016_49				
Comment Code					
EQ : Equipment					
Inspector Comment					
Junk truck at landward toe.

Looking east at truck and other farm equipment at landward toe.

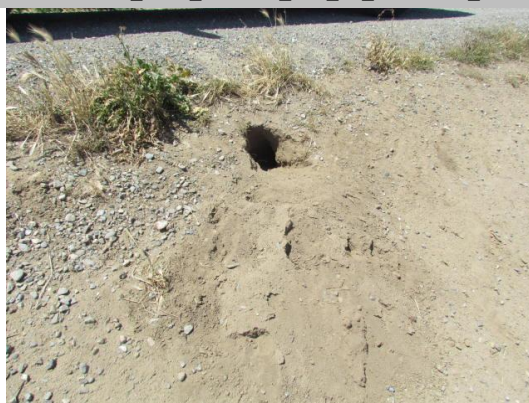
Photo 1 of 2 : SP_2017_RD2063_112_29_20170411_00009.jpg

LM Start	3.68	Rating **	M	Issue No.	29
LM End	3.76	Issue Type +	Ma	Location *	LS
Category	Earthen Levee			GPS Latitude/Longitude	
				Start	End
Item	Animal Control			37.436421 °	37.435767 °
				-121.017321 °	-121.016119 °
DWR ID	DWR_RD2063_01_s_2012_29				
Comment Code					
A3 : No rodents visible, but rodent burrows visible; need to backfill and compact or grout burrows.					
Inspector Comment					
Several rodent holes on landward shoulder and slope.

Looking east at typical rodent hole on landward shoulder.

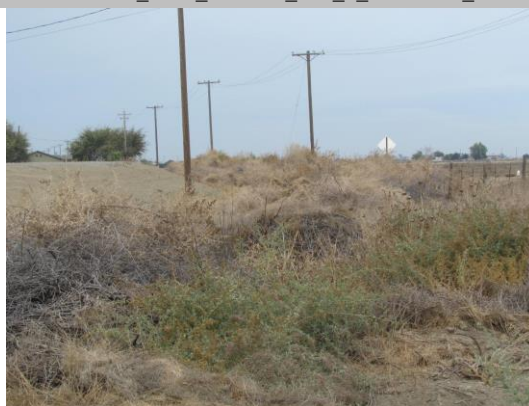
Photo 1 of 2 : SP_2017_RD2063_112_2_20170411_00001.jpg

LM Start	3.89	Rating **	M	Issue No.	2
LM End	3.97	Issue Type +	Ma	Location *	LS
Category	Earthen Levee			GPS Latitude/Longitude	
				Start	End
Item	Vegetation			37.434506 °	37.433441 °
				-121.014394 °	-121.013633 °
DWR ID	DWR_RD2063_01_s_2016_2				
Comment Code					
V2 : Remove the wild growth other than native grasses from the levee slopes.					
Inspector Comment					
Remove dense veg on landward berm.

Looking north at dense veg at landward toe and berm.

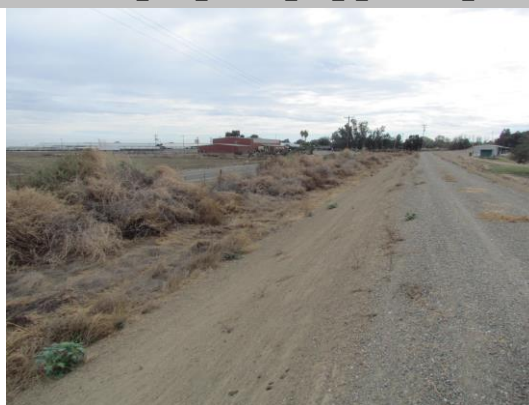
Photo 2 of 2 : SP_2017_RD2063_112_2_20170411_00002.jpg

Looking south at dense veg at landward toe and berm.

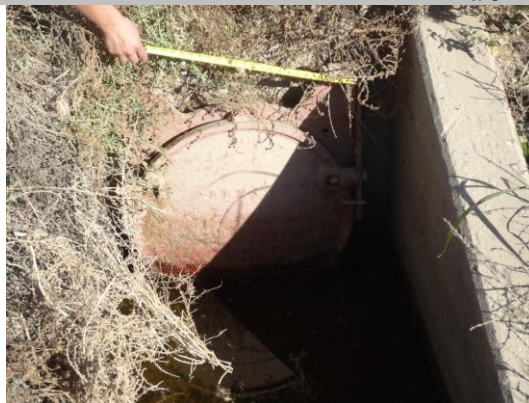
Photo 1 of 3 : UCIP_SP_2017_51821_43842.jpg

WS view: pipe, flap gate, and concrete headwall on drainage ditch.

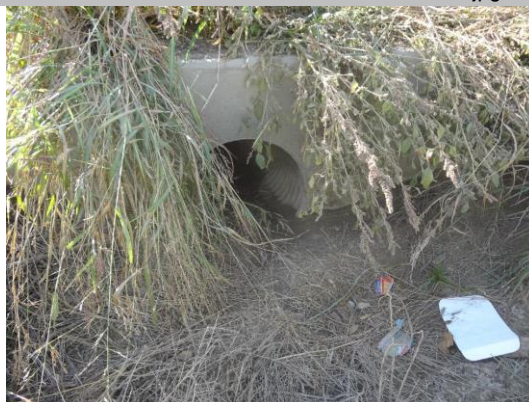
Photo 2 of 3 : UCIP_SP_2017_51821_43841.jpg

LS view: CM pipe and concrete headwall on levee toe.

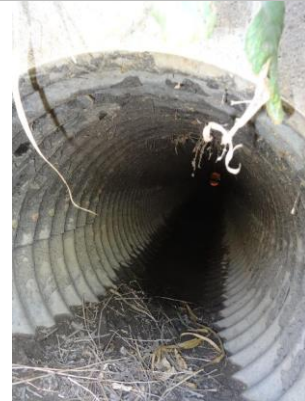
Photo 3 of 3 : UCIP_SP_2017_51821_43840.jpg

Item	DWR UCIP LMA Responsibility			37.432813 °	37.432813 °	
				-121.013419 °	-121.013419 °	
DWR ID						
Comment Code						
Inspector Comment						
FS_ID:51821 DS_ID:22096 EP_NO: N/A Repair Type: No Action Needed Crossing Status: Found UCIP Comments: 05/11/2017 Review of photos indicate less than 1/4 of the inlet is silted in. Since the pipe is in good condition, it has been downgraded from Non-Urgent to No Action Needed. (K. Fazel - UCIP)11/05/2013:- new flap gate on waterside.- cleaning of outlet and inlet pipes required. (P. Amatya - DWR) FIELD_STRUCT_DESC: 24-inch CM pipe through the levee 12.0 feet below the crown. Flap gate on the waterwad end. Concrete headwall on both ends. Installed by USCE 1961. O&M Manual SJR 006, Sept. 1961 FS Date: 11/5/2013

LS view: inside view of the CM pipe on levee toe.

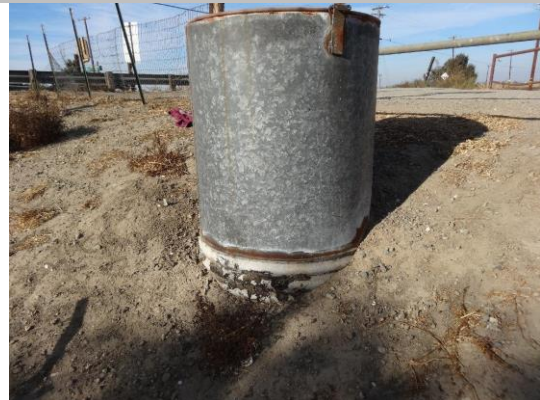
Photo 1 of 3 : UCIP_SP_2017_41746_43850.jpg

Comment Code					
Inspector Comment					
FS_ID:41746					
DS_ID:22099					
EP_NO: N/A					
Repair Type: Non-Urgent					
Crossing Status: Found					
UCIP Comments: Need to determine if annular space has been grouted or if repair/sleeving was done in accordance with a permit or Title 23.					
Slide gate not found in CM pipe riser on the waterward slope.Dense vegetation on waterside.Pipe only visible in CMP riser on waterside slope.					
FIELD_STRUCT_DESC: A smaller pipe sleeved into 24-inch CM pipe. 24-inch pipe through the levee 10.0 feet below the crown. Connects to concrete pipe irrigation system. Installed by USCE 1961. O&M Manual SJR 006, Sept. 1961.					
FS Date: 11/5/2013

WS view: CMP riser on levee slope. Steel riser on top of CMP.

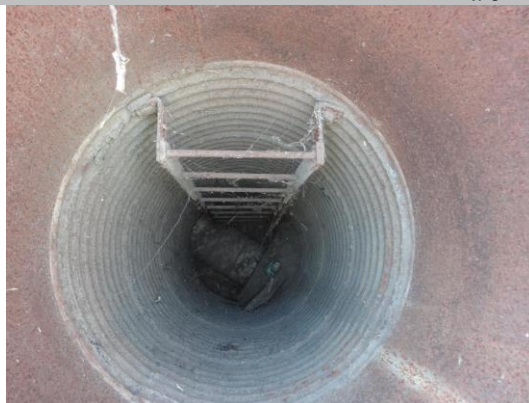
Photo 2 of 3 : UCIP_SP_2017_41746_43849.jpg

WS view: inside view of CMP riser on levee slope. Steel pipe and 24" CMP visible inside the riser.

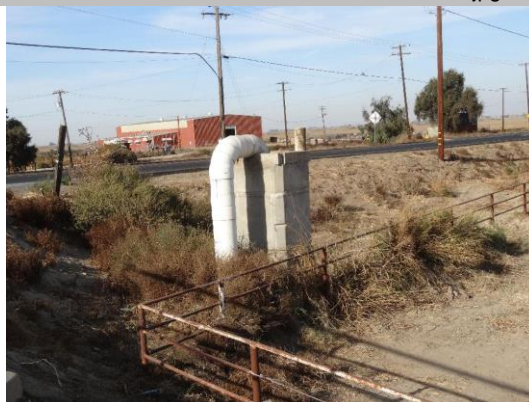
Photo 3 of 3 : UCIP_SP_2017_41746_43848.jpg

Comment Code						
Inspector Comment						
FS_ID:41746 DS_ID:22099 EP_NO: N/A Repair Type: Non-Urgent Crossing Status: Found UCIP Comments: Need to determine if annular space has been grouted or if repair/sleeving was done in accordance with a permit or Title 23. Slide gate not found in CM pipe riser on the waterward slope.Dense vegetation on waterside.Pipe only visible in CMP riser on waterside slope. FIELD_STRUCT_DESC: A smaller pipe sleeved into 24-inch CM pipe. 24-inch pipe through the levee 10.0 feet below the crown. Connects to concrete pipe irrigation system. Installed by USCE 1961. O&M Manual SJR 006, Sept. 1961. FS Date: 11/5/2013

LS view: discharge pipe and concrete distribution box on levee toe.

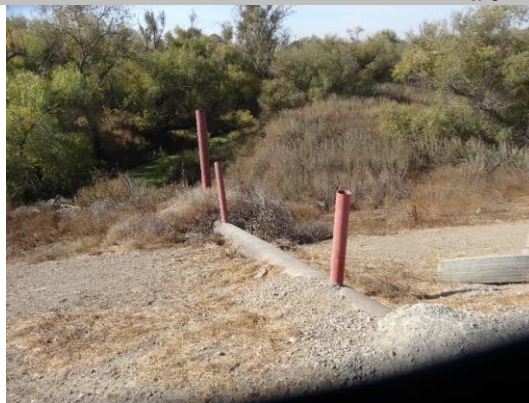
Photo 1 of 3 : UCIP_SP_2017_25025_45110.jpg

LM Start	4.17	Rating **	M	Issue No.	75	
LM End	4.17	Issue Type +	En	Location *	LS	
Category	Supplemental			GPS Latitude/Longitude		
				Start		End
Item	DWR UCIP Field Study			37.431029 °		37.431029 °
				-121.011865 °		-121.011865 °
DWR ID						
Comment Code						
Inspector Comment						
FS_ID:25025 DS_ID:24732 EP_NO: N/A Repair Type: Non-Urgent Crossing Status: Found UCIP Comments: - new pipe to pump.- overhead power line.- soil cover over the pipe seems not enough. FIELD_STRUCT_DESC: A 24-inch steel pipe through the levee at crown level. A thin layer of dirt acts as cover to the pipe. Pump house on steel structure in landside drainage ditch. Pump house and pipe on landside look new. Old wooden walkway to the pumphouse. Three new air vents on waterside pipe. Pipe opens on waterside. Exposed old pipe on waterside. FS Date: 11/6/2013

WS view: air vents (top- red) on exposed steel pipe.

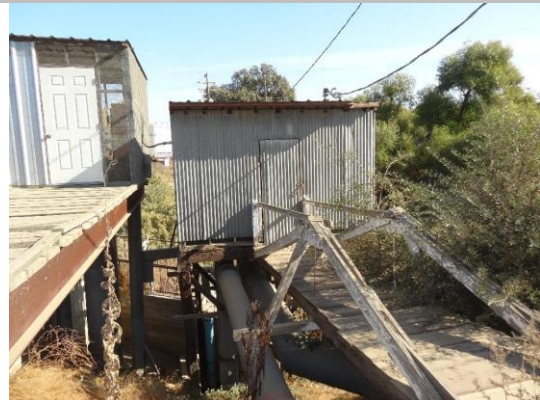
Photo 1 of 3 : UCIP_SP_2017_24603_43860.jpg

LM Start	4.17	Rating **	A/W	Issue No.	76
LM End	4.17	Issue Type +	Ma	Location *	LS
Category	Supplemental			GPS Latitude/Longitude	
				Start	End
Item	DWR UCIP LMA Responsibility			37.431005 °	37.431005 °
				-121.011843 °	-121.011843 °
DWR ID					
Comment Code					
Inspector Comment					
FS_ID:24603 DS_ID:22100 EP_NO: 6721 Repair Type: No Action Needed Crossing Status: Found UCIP Comments: - Overhead power line.- looks new inlet pipes in pumphouse. FIELD_STRUCT_DESC: 1 of 3: A 18-inch and 20 steel pipes through the levee 2.0 feet below the crown. Pumphouse and timber walkway on the landward side. 16-inch steel pipe through the levee 3.6 feet below the crown. (App. No. 6721 and A). O&M Manual SJR 006, Sept. 1961. FS Date: 11/6/2013

LS view: walkway to pump, pump house (right), and pipes on levee

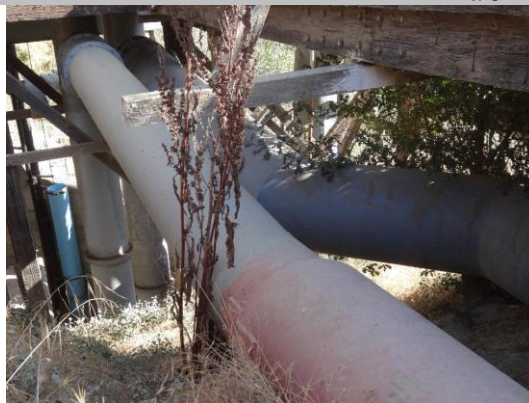
Photo 2 of 3 : UCIP_SP_2017_24603_43862.jpg

LS view: pipes (18" pipe - left, 20" pipe- right) under walkway and pump house on levee slope.

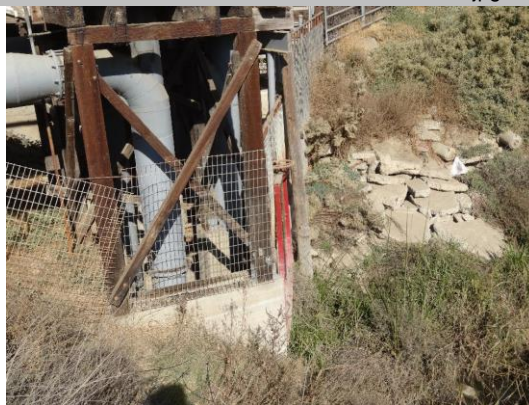
Photo 3 of 3 : UCIP_SP_2017_24603_43861.jpg

LS view: intake sump under pump house, and pipes in drainage ditch.

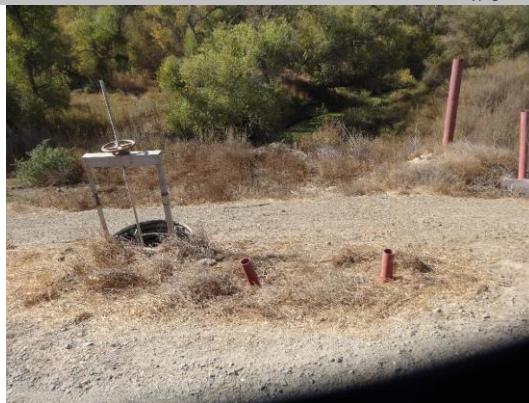
Photo 1 of 3 : UCIP_SP_2017_25026_45115.jpg

LM Start	4.17	Rating **	A/W	Issue No.	77
LM End	4.17	Issue Type +	Ma	Location *	LS
Category	Supplemental			GPS Latitude/Longitude	
				Start	End
Item	DWR UCIP LMA Responsibility			37.431003 °	37.431003 °
				-121.011834 °	-121.011834 °
DWR ID					
Comment Code					
Inspector Comment					
FS_ID:25026 DS_ID:22120 EP_NO: 6721 Repair Type: No Action Needed Crossing Status: Found UCIP Comments: New intake pipe to pump.Pump house on concrete sump in drainage ditch. FIELD_STRUCT_DESC: 2 of 3: A 20-inch and 18-inch steel pipes through the levee 2.0 feet below the crown. Pumphouse and timber walkway on the landward side. 16-inch steel pipe through the levee 3.6 feet below the crown. (App. No. 6721 and A). O&M Manual SJR 006, Sept. 1961. FS Date: 11/6/2013

WS view: air vents (red) on levee slope.

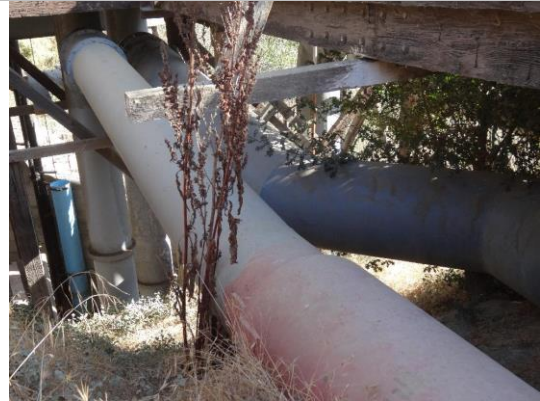
Photo 3 of 3 : UCIP_SP_2017_25026_45117.jpg

LS view: 18" steel pipe (left) and 20" steel pipe (right) under walkway.

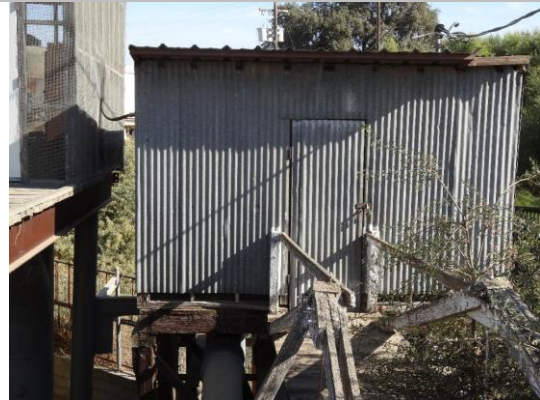
Photo 1 of 3 : UCIP_SP_2017_25027_45120.jpg

LS view: walkway to pump and pump house on levee slope.

FS_ID:25027
DS_ID:22121
EP_NO: 6721
Repair Type: No Action Needed
Crossing Status: Found
UCIP Comments: - new intake pipe to the pump.- overhead power line.
FIELD_STRUCT_DESC: 3 of 3: 16-inch steel pipe through the levee 3.6 feet below the crown. Pumphouse and timber walkway on the landward side. A 18-inch and 20 steel pipes through the levee 2.0 feet below the crown. (App. No. 6721 and A). O&M Manual SJR 006, Sept. 1961.
FS Date: 11/6/2013

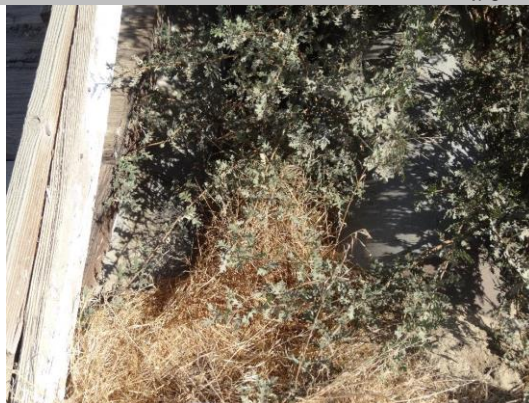
Photo 2 of 3 : UCIP_SP_2017_25027_45119.jpg

LS view: walkway to pump and pipe (right) on levee slope.

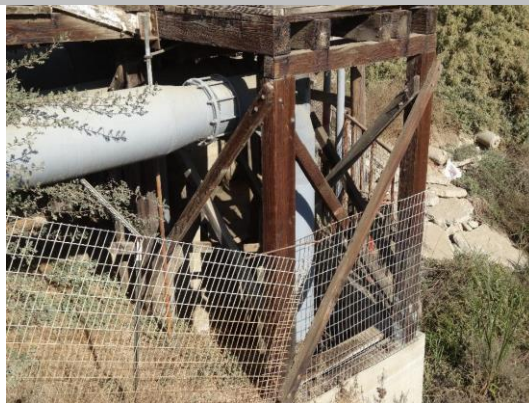
Photo 3 of 3 : UCIP_SP_2017_25027_45118.jpg

LS view: intake pipes and pump house on concrete sump in drainage ditch.

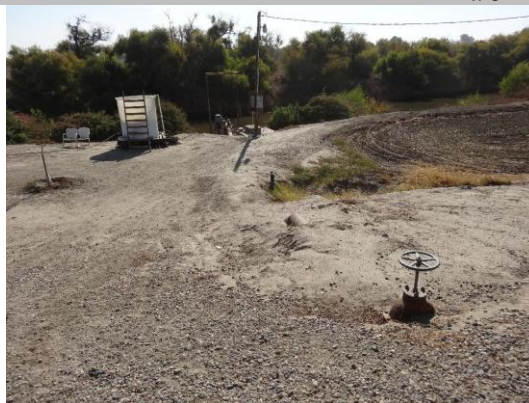
Photo 1 of 3 : UCIP_SP_2017_25028_45125.jpg

LM Start	4.58	Rating **	M	Issue No.	79
LM End	4.58	Issue Type +	En	Location *	LS
Category	Supplemental			GPS Latitude/Longitude	
				Start	End
Item	DWR UCIP Field Study			37.429501 °	37.429501 °
				-121.005667 °	-121.005667 °
DWR ID					
Comment Code					
Inspector Comment					
FS_ID:25028 DS_ID:22103 EP_NO: N/A Repair Type: Non-Urgent Crossing Status: Found UCIP Comments: Leaky pipe joint on landside where pipe daylights.Power pole on waterside. FIELD_STRUCT_DESC: 10-inch steel pipe through the levee 4.0 feet below the crown. Gate valve on waterside slope. Siphon breaker on landside slope. Pipe daylights halfway down landward slope and empties into a concrete standpipe at landward toe. Pump at top of the bank on waterside. Installed by USCE 1961. O&M Manual SJR 006, Sept. 1961. FS Date: 11/6/2013

WS view: overview of waterside- gate valve and power pole on levee slope.

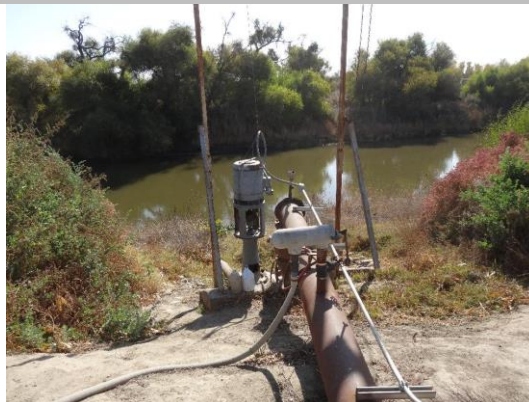
Photo 2 of 3 : UCIP_SP_2017_25028_45124.jpg

WS view: pump, pipe and other appurtenances on levee toe.

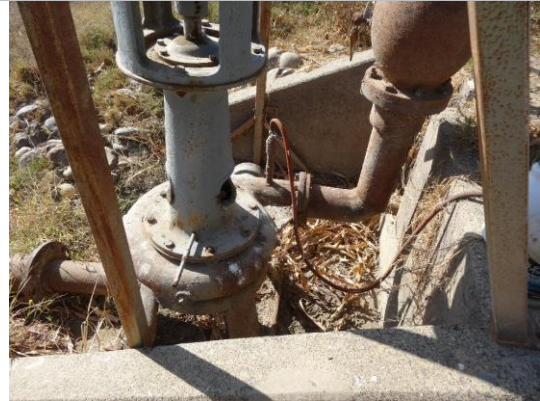
Photo 3 of 3 : UCIP_SP_2017_25028_45123.jpg

Comment Code						
Inspector Comment						
FS_ID:25028						
DS_ID:22103						
EP_NO: N/A						
Repair Type: Non-Urgent						
Crossing Status: Found						
UCIP Comments: Leaky pipe joint on landside where pipe						
daylights.Power pole on waterside.						
FIELD_STRUCT_DESC: 10-inch steel pipe through the levee 4.0 feet						
below the crown. Gate valve on waterside slope. Siphon breaker on						
landside slope. Pipe daylights halfway down landward slope and						
empties into a concrete standpipe at landward toe. Pump at top of the						
bank on waterside. Installed by USCE 1961. O&M Manual SJR 006,						
Sept. 1961.						
FS Date: 11/6/2013

WS view: U type headwall and pump on river bank.

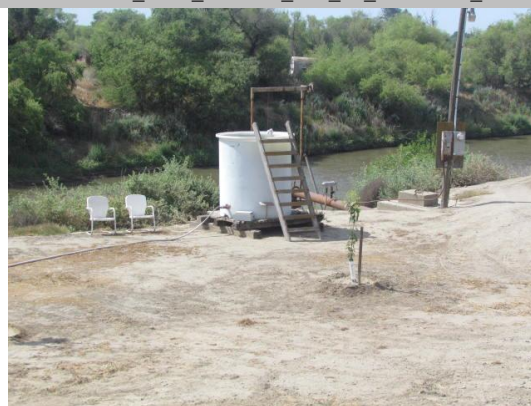
Photo 1 of 2 : SP_2017_RD2063_112_31_20170411_00011.jpg

LM Start	4.60	Rating **	M	Issue No.	31
LM End	4.60	Issue Type +	En	Location *	WS
Category	Earthen Levee			GPS Latitude/Longitude	
				Start	End
Item	Encroachments			37.429638 °	37.429638 °
				-121.005348 °	-121.005348 °
DWR ID	DWR_RD2063_01_s_2012_31				
Comment Code					
CR : Crops					
Inspector Comment					
Landowner planted grape vines and fruit trees and water tank on waterside berm without a permit from the CVFPB.

Looking west at water tank on waterward berm.

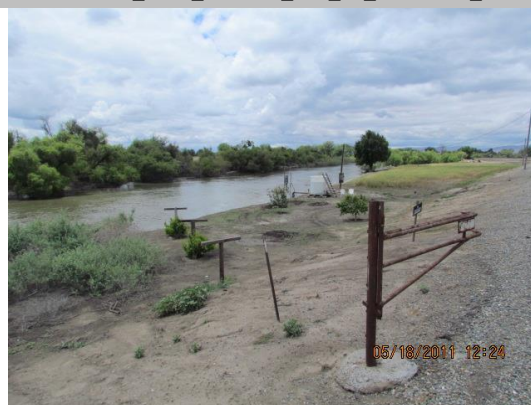
Photo 2 of 2 : SP_2017_RD2063_112_31_20170411_00012.jpg

Looking south at grapevines and fruit trees on waterside berm.

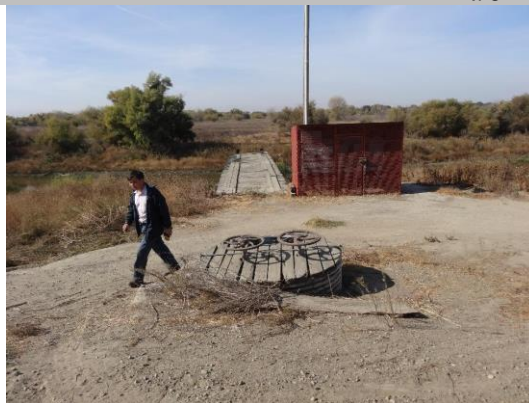
Photo 1 of 3 : UCIP_SP_2017_41669_45131.jpg

Comment Code					
Inspector Comment					
FS_ID:41669					
DS_ID:22105					
EP_NO: N/A					
Repair Type: Non-Urgent					
Crossing Status: Found					
UCIP Comments: Abandoned pipe should be done so properly.- rubber pipe attached to steel pipe on waterside.- a concrete standpipe on landside too.- overhead power line.- abandoned pipe and pile structure. Abandoned timber walkway on waterside.					
FIELD_STRUCT_DESC: 1 of 2: Two 12-inch steel pipes encased in reinforced concrete through levee 9.0 feet below crown. Two slide gates in 72-inch CM pipe riser on waterward slope. Two pumps on floating structure in river. Concrete distribution box on landward toe of the levee. Installed by USCE 1961. O&M Manual SJR 006, Sept. 1961.					
FS Date: 11/6/2013

WS view: CMP riser, abandoned walkway, power pole on levee slope.

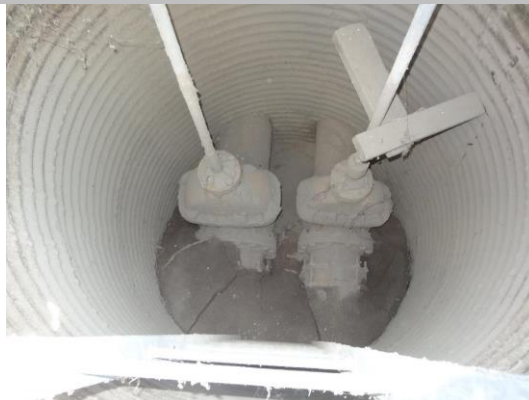
Photo 2 of 3 : UCIP_SP_2017_41669_45130.jpg

WS view: two gate valves inside CMP riser on levee slope.

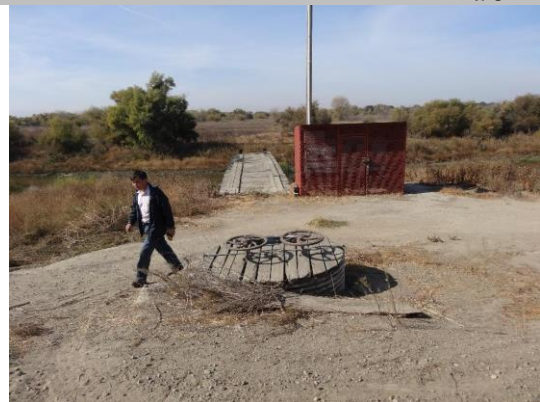
Photo 1 of 3 : UCIP_SP_2017_41670_43905.jpg

Comment Code					
Inspector Comment					
FS_ID:41670 DS_ID:22123 EP_NO: N/A Repair Type: Non-Urgent Crossing Status: Found UCIP Comments: Any abandoned pipes should be verified as having been abandoned properly. - abandoned walkway, pile structure and steel pipe.- concrete standpipe on landside toe.- overhead power line. FIELD_STRUCT_DESC: 2 of 2: Two 12-inch steel pipes encased in reinforced concrete through levee 9.0 feet below crown. Two slide gates in 72-inch CM pipe riser on waterward slope. Two pumps on floating structure in river. Concrete distribution box on landward toe of the levee. Installed by USCE 1961. O&M Manual SJR 006, Sept. 1961. FS Date: 11/6/2013

WS view: CMP riser, abandoned walkway, power pole on levee slope.

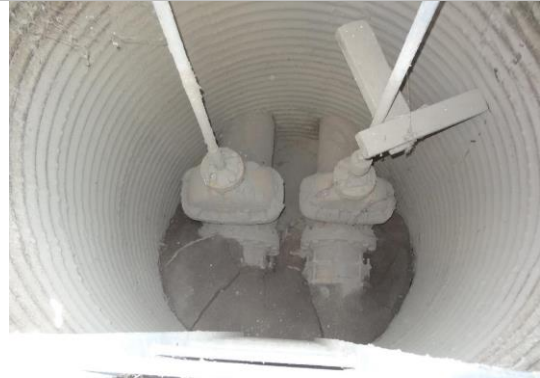
Photo 2 of 3 : UCIP_SP_2017_41670_43904.jpg

WS view: two gate valves inside CMP riser on levee slope.

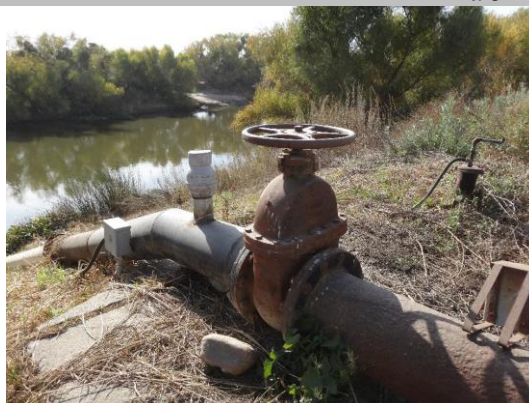
Photo 1 of 3 : UCIP_SP_2017_24628_43938.jpg

LM Start	6.53	Rating **	M	Issue No.	82
LM End	6.53	Issue Type +	En	Location *	WS
Category	Supplemental			GPS Latitude/Longitude	
				Start	End
Item	DWR UCIP Field Study			37.411347 °	37.411347 °
				-120.998063 °	-120.998063 °
DWR ID					
Comment Code					
Inspector Comment					
FS_ID:24628 DS_ID:22108 EP_NO: 4062 Repair Type: Non-Urgent Crossing Status: Found UCIP Comments: Abandoned pipe also found adjacent to this pipe. Needs proper abandonment.Soil erosion under pipe on waterside. No pipe visible on landside.Overhead powerline. FIELD_STRUCT_DESC: 12-inch pvc pipe through the levee 3.0 feet below the crown. Float pump in the river. Gate valve and air vent on waterside levee berm. Service pole with overhead line on the waterward shoulder. (App. No. 4062 - Greer) FS Date: 11/6/2013

WS view: steel pipe, gate valve, air vent on levee berm.

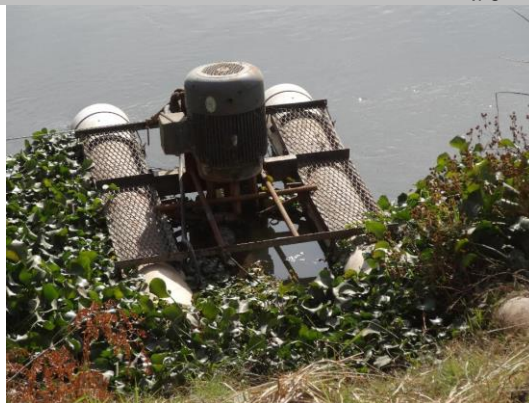
Photo 2 of 3 : UCIP_SP_2017_24628_43937.jpg

WS view: pump on floating structure in the stream.

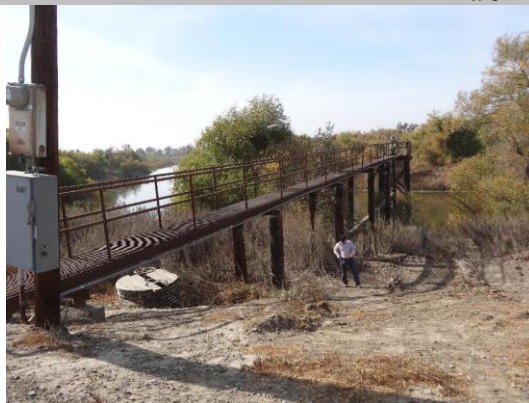
Photo 1 of 3 : UCIP_SP_2017_24629_43943.jpg

LM Start	6.96	Rating **	M	Issue No.	83
LM End	6.96	Issue Type +	En	Location *	WS
Category	Supplemental			GPS Latitude/Longitude	
				Start	End
Item	DWR UCIP Field Study			37.409073 °	37.409073 °
				-120.992041 °	-120.992041 °
DWR ID					
Comment Code					
Inspector Comment					
FS_ID:24629 DS_ID:22109 EP_NO: 13541 Repair Type: Non-Urgent Crossing Status: Found UCIP Comments: - erosion around CMP riser on waterside- no U type headwall found on landside.- no pipe found on landside. FIELD_STRUCT_DESC: 16-inch steel pipe through the levee 10.0 feet below the crown. Gate valve in CM pipe riser on the waterward slope. Pump on bank. Concrete "U" headwall on landward side. Installed by USCE 1961. (App. No. 13541 replace pump). O&M Manual SJR 006, Sept. 1961 FS Date: 11/6/2013

WS view: power pole, walkway to pump, CMP riser, and pipe on waterside slope.

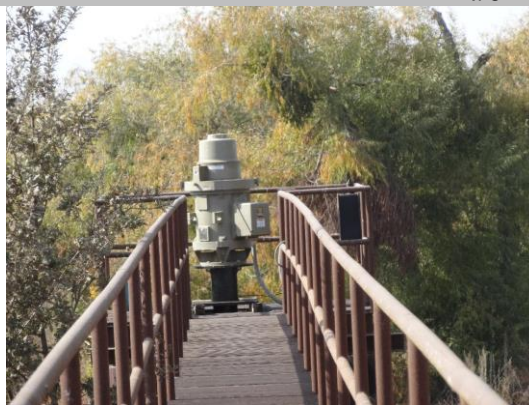
Photo 2 of 3 : UCIP_SP_2017_24629_43942.jpg

WS view: walkway to pump and pump on pile structure in the stream.

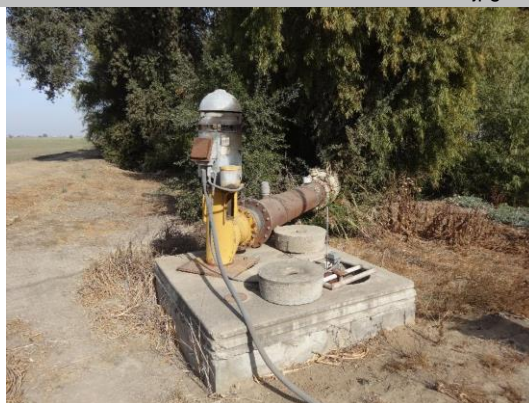
Photo 3 of 3 : UCIP_SP_2017_24632_43951.jpg

LM Start	7.48	Rating **	A/W	Issue No.	84 (cont)
LM End	7.48	Issue Type +	Ma	Location *	WS
Category	Supplemental			GPS Latitude/Longitude	
				Start	End
Item	DWR UCIP LMA Responsibility			37.404195 °	37.404195 °
				-120.986709 °	-120.986709 °
DWR ID					
Comment Code					
Inspector Comment					
FS_ID:24632 DS_ID:22110 EP_NO: N/A Repair Type: No Action Needed Crossing Status: Found UCIP Comments: No pipe visible on landside.Flap gate not found on the waterside end. Concrete "U" headwalls not found on ends of pipe. FIELD_STRUCT_DESC: 36-inch CM pipe through the levee 25.5 feet below the crown. Slide gate in CM pipe riser on the waterward slope. Installed by USCE 1961. O&M Manual SJR 006, Sept. 1961. FS Date: 11/6/2013

LS view: concrete distribution box on levee toe. Pump on the box discharges water into irrigation ditch.

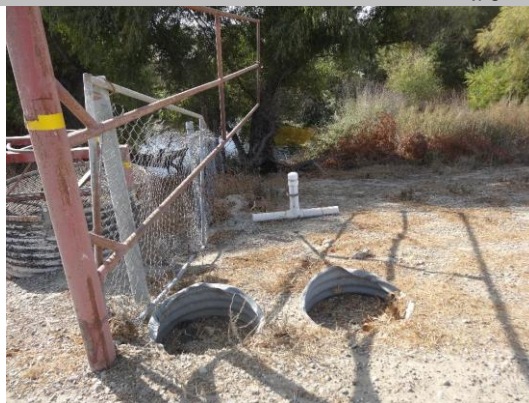
Photo 1 of 3 : UCIP_SP_2017_24651_44005.jpg

LM Start	8.46	Rating **	M	Issue No.	86
LM End	8.46	Issue Type +	Ma	Location *	LS
Category	Supplemental			GPS Latitude/Longitude	
				Start	End
Item	DWR UCIP LMA Responsibility			37.397883 °	37.397883 °
				-120.972342 °	-120.972342 °
DWR ID					
Comment Code					
Inspector Comment					
FS_ID:24651 DS_ID:22124 EP_NO: N/A Repair Type: Non-Urgent Crossing Status: Found UCIP Comments: - working during field inspection.- blocked siphon breaker. FIELD_STRUCT_DESC: 1 of 2: Two 16-inch steel pipes through the levee 3.5 feet below the crown. Siphon breakers in CM pipe risers on the waterward slope. Flap gate on the waterward end of each pipe. Two pumps on timber pile structure on the landward side. Timber walkway from levee to pump structure. O&M Manual SJR 006, Sept. 1961. FS Date: 11/6/2013

WS view: two siphon breakers in CMP risers on levee slope.

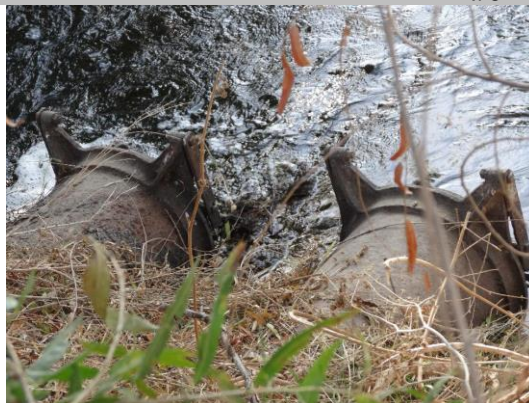
Photo 2 of 3 : UCIP_SP_2017_24651_44004.jpg

WS view: two flap gates on outfall pipe ends.

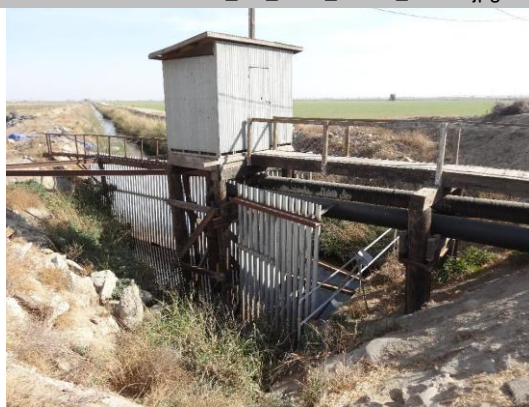
Photo 3 of 3 : UCIP_SP_2017_24651_44003.jpg

LS view: pipes under walkway to pump house.

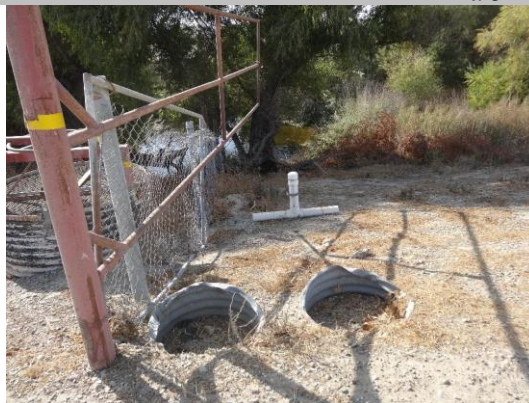
Photo 1 of 3 : UCIP_SP_2017_24652_44008.jpg

LM Start	8.46	Rating **	M	Issue No.	87
LM End	8.46	Issue Type +	Ma	Location *	LS
Category	Supplemental			GPS Latitude/Longitude	
				Start	End
Item	DWR UCIP LMA Responsibility			37.397872 °	37.397872 °
				-120.972336 °	-120.972336 °
DWR ID					
Comment Code					
Inspector Comment					
FS_ID:24652 DS_ID:22112 EP_NO: N/A Repair Type: Non-Urgent Crossing Status: Found UCIP Comments: - working during field inspection.- blocked siphon breaker. FIELD_STRUCT_DESC: 2 of 2: Two 16-inch steel pipes through the levee 3.5 feet below the crown. Siphon breakers in CM pipe risers on the waterward slope. Flap gate on the waterward end of each pipe. Two pumps on timber pile structure on the landward side. Timber walkway from levee to pump structure. O&M Manual SJR 006, Sept. 1961. FS Date: 11/6/2013

WS view: two siphon breakers in CMP risers on levee slope.

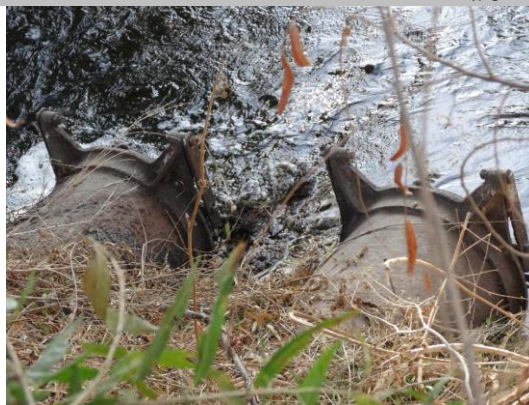
Photo 2 of 3 : UCIP_SP_2017_24652_44007.jpg

WS view: two flap gates on outfall pipe ends.

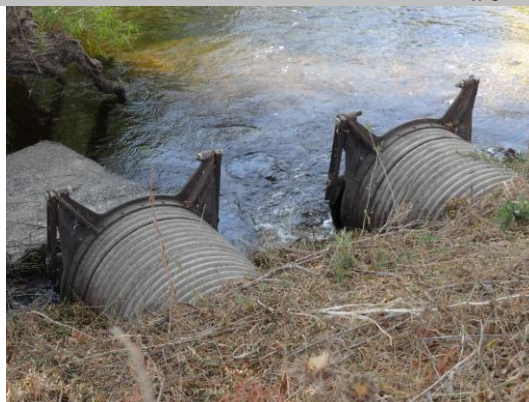
Photo 1 of 3 : UCIP_SP_2017_24650_44002.jpg

LM Start	8.46	Rating **	A/W	Issue No.	88
LM End	8.46	Issue Type +	Ma	Location *	LS
Category	Supplemental			GPS Latitude/Longitude	
				Start	End
Item	DWR UCIP LMA Responsibility			37.397865 °	37.397865 °
				-120.972332 °	-120.972332 °
DWR ID					
Comment Code					
Inspector Comment					
FS_ID:24650 DS_ID:22113 EP_NO: N/A Repair Type: No Action Needed Crossing Status: Found UCIP Comments: Working during field inspection. FIELD_STRUCT_DESC: 1 of 2: Two 42-inch CM pipes through levee 18.0 feet below the crown. Slide gates in CM pipe risers on the waterward slope. Flap gates, concrete saddle and apron on the waterside ends of pipes.Concrete headwall on landward end. Reclamation District No. 2063 Pumping Plant. O&M Manual SJR 006, Sept. 1961. FS Date: 11/6/2013

WS view: two flap gates on outfall pipe ends.

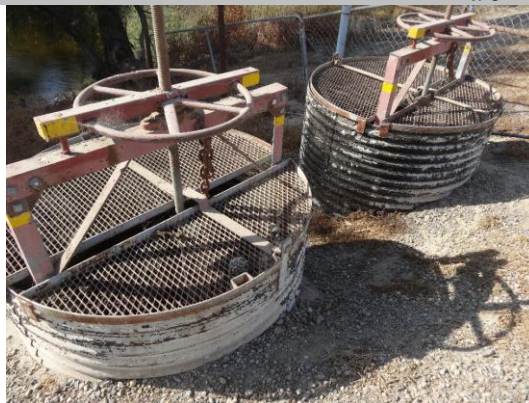
Photo 2 of 3 : UCIP_SP_2017_24650_44001.jpg

WS view: two slide gates in CMP risers on levee slope.

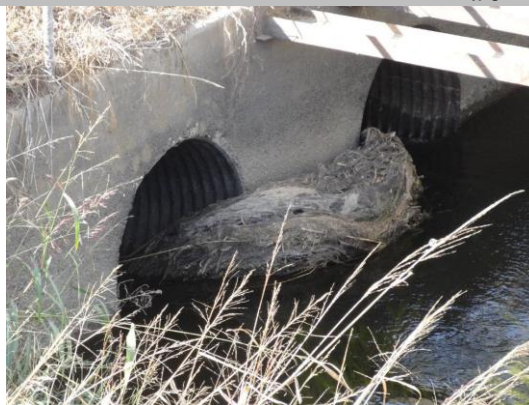
Photo 3 of 3 : UCIP_SP_2017_24650_44000.jpg

LS view: drainage pipes under walkway in drainage ditch.

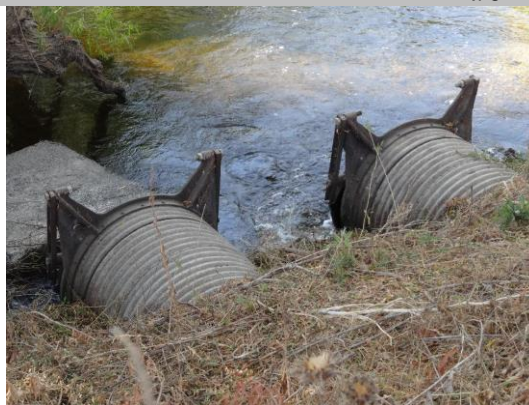
Photo 2 of 3 : UCIP_SP_2017_24636_43964.jpg

LM Start	8.46	Rating **	A/W	Issue No.	89
LM End	8.46	Issue Type +	Ma	Location *	LS
Category	Supplemental			GPS Latitude/Longitude	
				Start	End
Item	DWR UCIP LMA Responsibility			37.397850 °	37.397850 °
				-120.972322 °	-120.972322 °
DWR ID					
Comment Code					
Inspector Comment					
FS_ID:24636 DS_ID:22125 EP_NO: N/A Repair Type: No Action Needed Crossing Status: Found UCIP Comments: - working during field inspection. FIELD_STRUCT_DESC: 2 of 2: Two 42-inch CM pipes through levee 18.0 feet below the crown. Slide gates in CM pipe risers on the waterward slope. Flap gates, concrete saddle and apron on the waterward ends of pipes. Concrete headwall on landward end. Reclamation District No. 2063 Pumping Plant. O&M Manual SJR 006, Sept. 1961. FS Date: 11/6/2013

WS view: two flap gates on outfall pipe ends.
